# Manhole Inspection Summary

Manhole # S43UU\_006MH

**Location** Address: **2627 TYLER ST** Cross Street: **GORSUCH AVE**

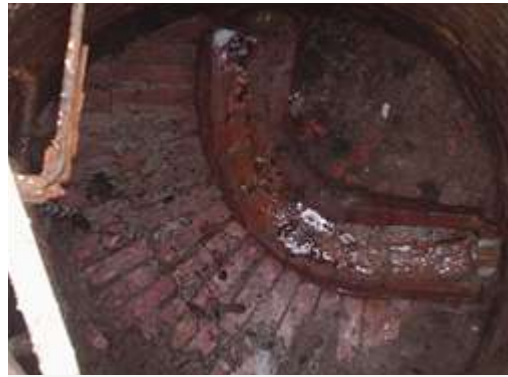
Top View

**Steps** Count: **4** Missing: **0** ☒ **Corroded**

**Surcharge** ☒ **Evidence Of Surcharge** Depth: **4.5** (ft.) ☐ Active Surcharge Present

Corroded steps. Evidence of surcharge - Bench debris.

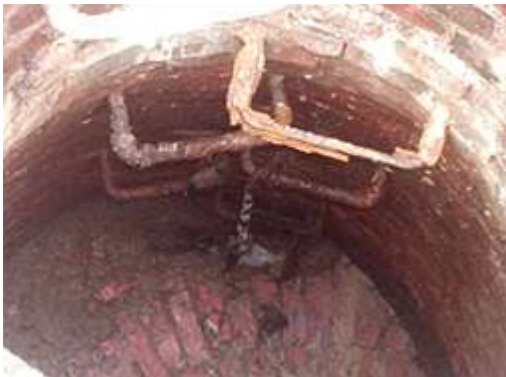
Defect

Adjustment, Corbel and Barrel infiltration.

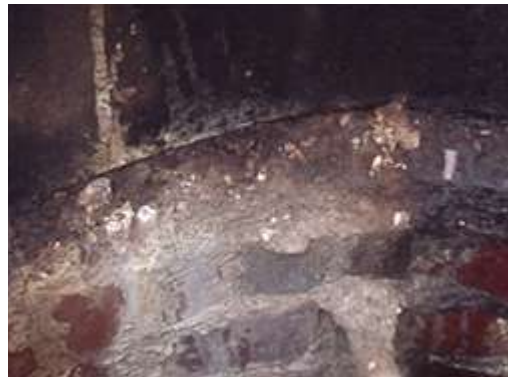
Defect

**Frame** Offset: **2** (in.) Condition: ☐ Sound ☐ Cracked ☒ **Leaks**

**Chimney / Frame Adjustment** ☒ Exists Material: **Brick** ☐ Parged Height: **3** (in.)  
Condition: ☐ Sound ☐ Cracked ☐ Root Intrusion ☐ Loose Brick ☒ **Deteriorated**  
Infiltration: ☐ None ☒ **Joint** ☐ Cracks ☐ Mortar ☐ Roots ☒ **Wall**

Frame leaks. Adjustment deterioration and infiltration.

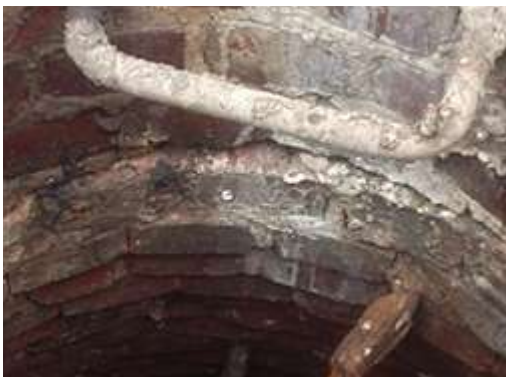
Defect

**Corbel** Material: **Brick** ☐ Parged Type: **Concentric/Eccentric**  
Condition: ☐ Sound ☐ Cracked ☐ Root Intrusion ☐ Loose Brick ☒ **Deteriorated**  
Infiltration: ☐ None ☐ Joint ☐ Cracks ☒ **Mortar** ☐ Roots ☒ **Wall**

Corbel deterioration and infiltration.

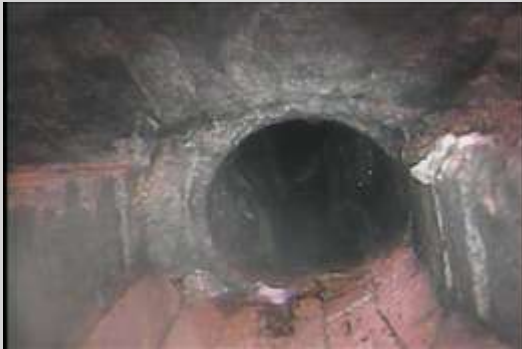
Pipe Out @ 12 O'Clock

**Channel** Material: **Brick** ☐ Parged ☐ Debris (not Condition related)  
Channel Exposure: **Fully Open** Junc Dist: **0** nearest .5 ft. Azimuth:  
Condition: ☐ Sound ☐ Cracked ☐ Root Intrusion ☒ **Deteriorated** ☐ Leaks ☐ Debris

Channel deterioration.
